UNITED STATES DISTRICT COURT
DISTRICT OF MARYLAND

CIVIL NO. L-08-33

MEMORANDUM

This case begins with a fire at the residence of Sharon and Robert McNutt on Kent Island in Stevensville, Maryland. The insurer of the McNutts' home, Plaintiff Erie Insurance Exchange ("Erie"), sues its subrogation target, Defendant Builder Services Group, Inc. ("BSG"), for negligent installation of a fireplace.¹ Now pending is BSG's Motion for Summary Judgment (Docket No. 30). In its motion, BSG seeks dismissal of the case on evidence spoliation grounds. On July 2, 2009, the Court held a three-hour hearing on BSG's pending motion. For the reasons stated herein, by separate Order, the Court will grant BSG's motion and dismiss the case.

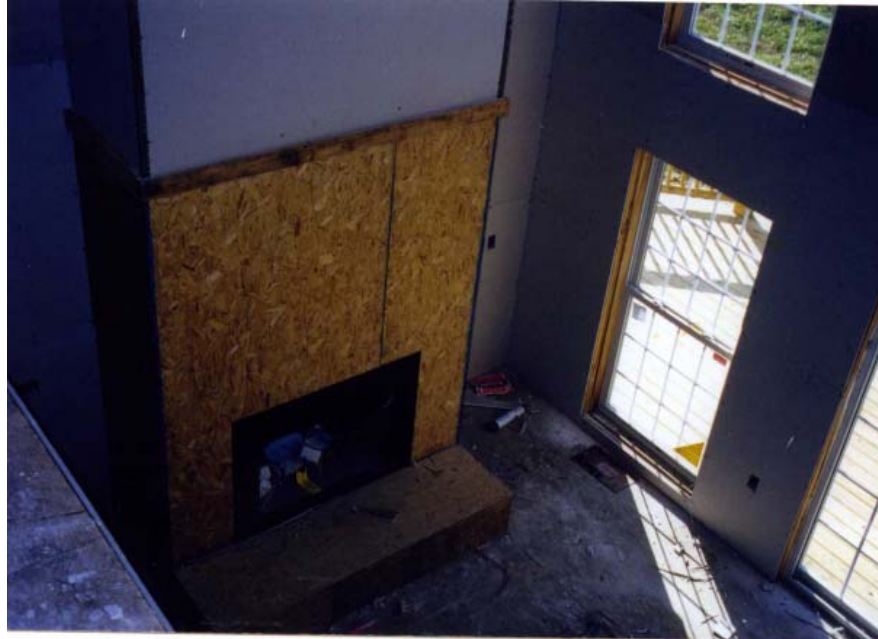
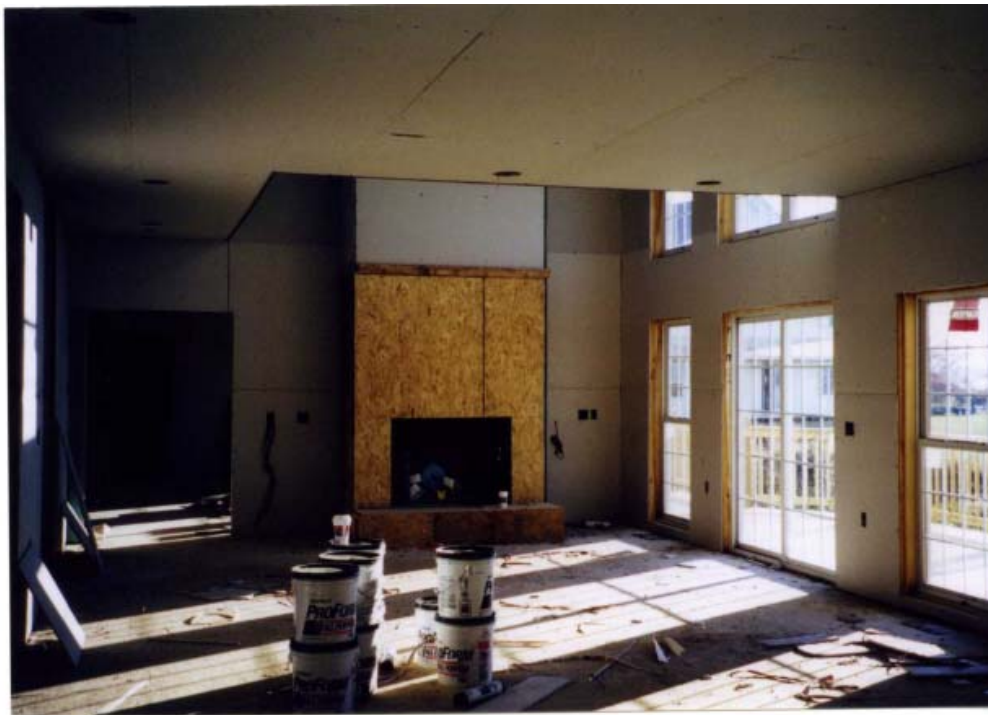
Figures 1 & 2

The McNutt family room during 1999 construction showing mantle and hearth before the stone facing was applied and before firebox was installed. Behind the fireplace area is the master bedroom.

The McNutts’ fireplace was in the family room, which shared a common wall with the master bedroom. The fireplace, which comprised a hearth and a stone-faced mantle/chimney, extended from the common wall into the family room. App’x, Figs. 1-4. The hearth/mantle consisted of a wood frame structure faced with stone. The hearth was elevated about one foot above the floor and extended about one foot into the family room in front of the mantle. Fig. 6. Inside the hearth was a metal insert (the “firebox”) that rested on a plywood base. Figs. 1-2.

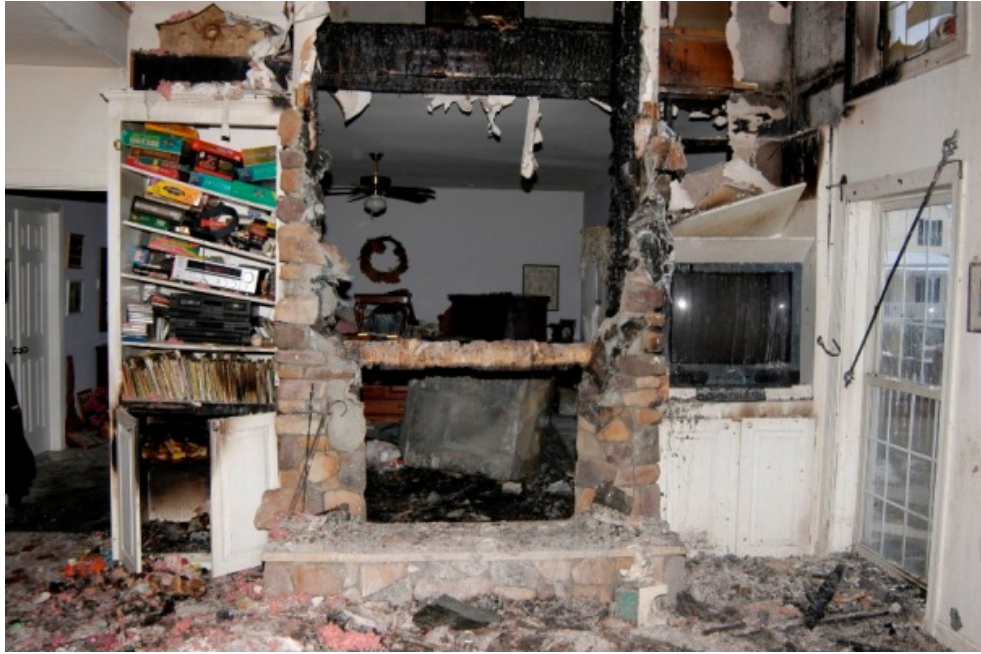
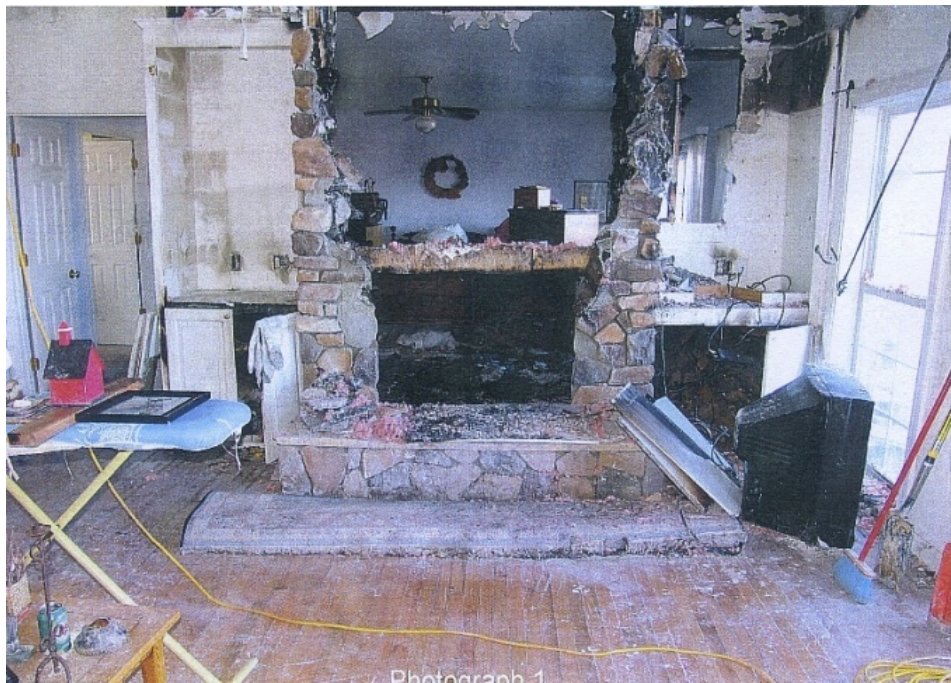
Figures 3 & 4

Stone-faced fireplace with firebox removed. The view is from the family room through the mantle into the master bedroom. The master bedroom has a ceiling fan and a wreath on the back wall. Figure 3 was taken immediately after the fire. Figure 4 was taken after some rehabilitation and debris removal had occurred.

The fire damage was extensive. Photographs taken by Erie's investigators show the condition of the house after the fire department had put out the fire. They show that the fire had charred the wall and ceiling above the firebox (Fig. 5), charred the area directly underneath the firebox (Fig. 7), and burned through the common wall behind the fireplace (Fig. 7). The fire does not appear to have substantially damaged the stone hearth or its wooden supports, however. Figs. 3-4, 6.

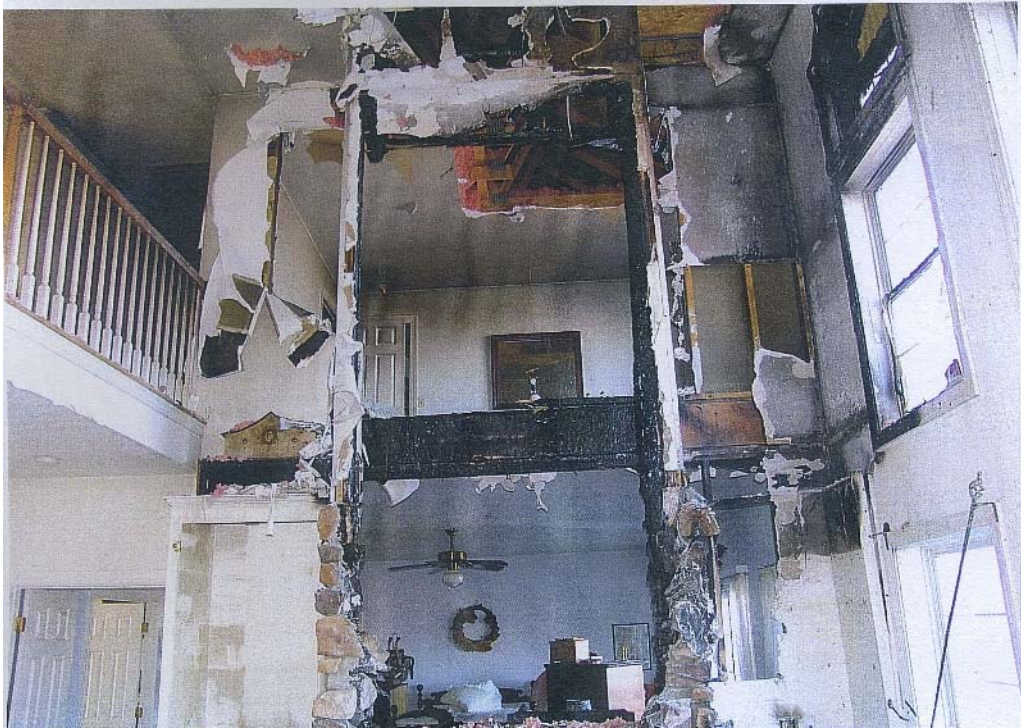
Figure 5

A vertical view of the living room looking through chimney area into first floor master bedroom and second floor hallway. Roof damage is apparent.

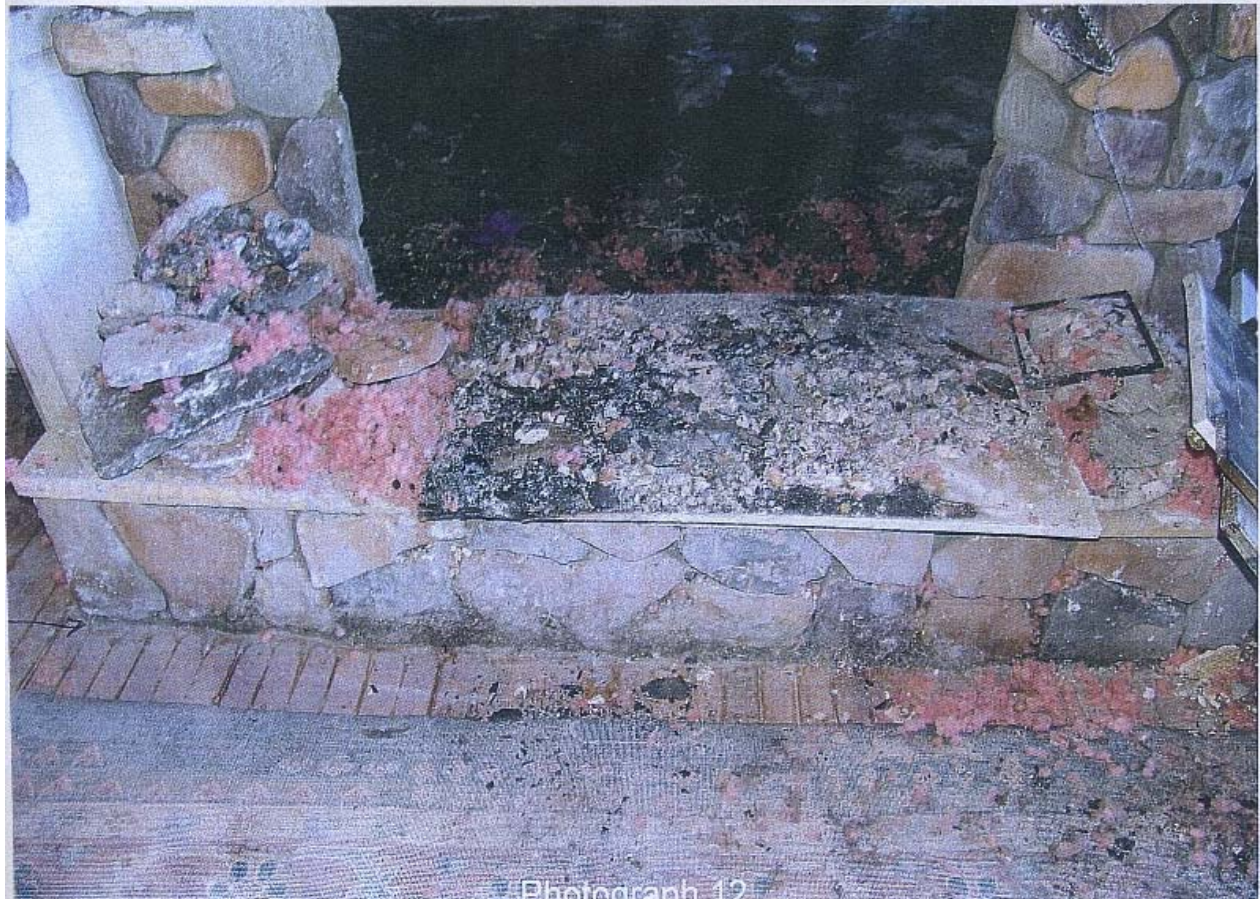
Figure 6

Close-up view of hearth with firebox removed. The stone hearth meets the mantle, which extends into the living room. The hearth is approximately one foot tall by one foot deep.

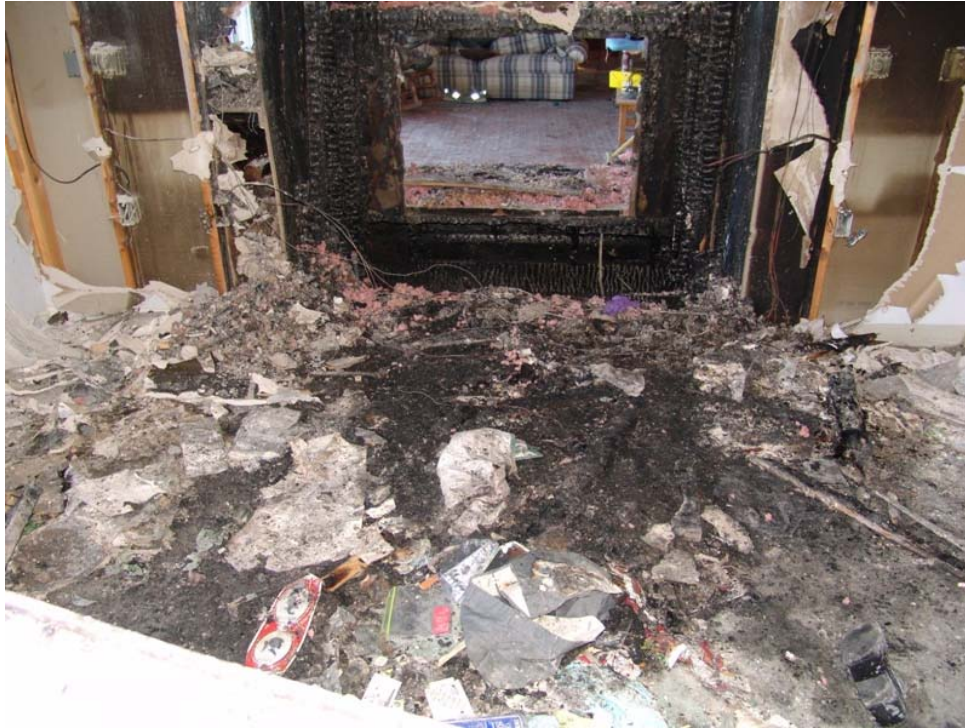
Figure 7

View of firebox area from master bedroom. This view looks through where the wall and firebox was into the living room where a couch is visible. A large number of wires are seen.

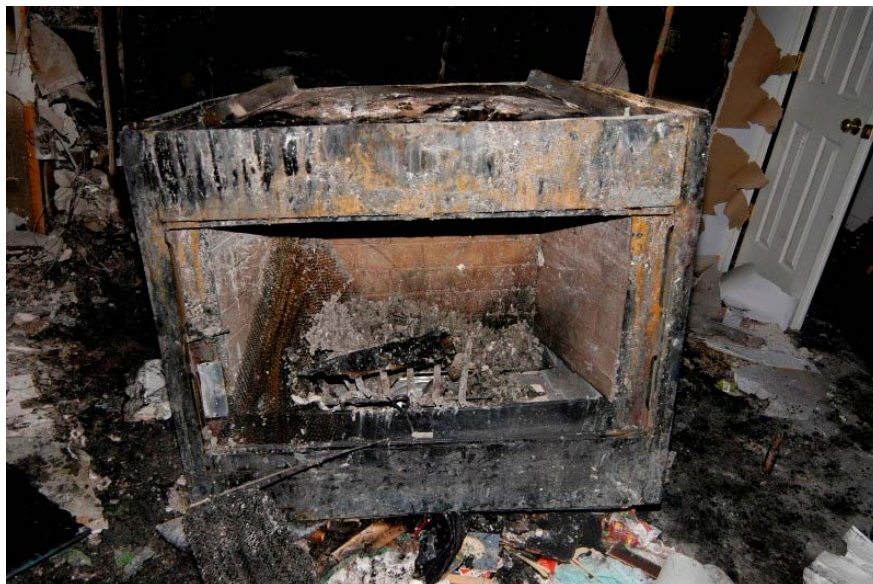
Figure 8

The prefabricated firebox sitting in the master bedroom. The wire screen is visible, but the previously attached glass doors are missing.

As evidenced by the photographs, when Erie's investigators arrived, they found a shambles as the firemen had (quite properly) torn apart much of the fireplace while putting out the fire. Debris was scattered throughout the first floor. The metal firebox had been torn out and deposited in the master bedroom (Fig. 8). The stone facing of the hearth was broken out in many places. Metal chimney tubing was cast onto the snow-covered deck and lawn. Personal effects were intermixed with overturned furniture. Many items are unidentifiable because they were covered by ripped out insulation.

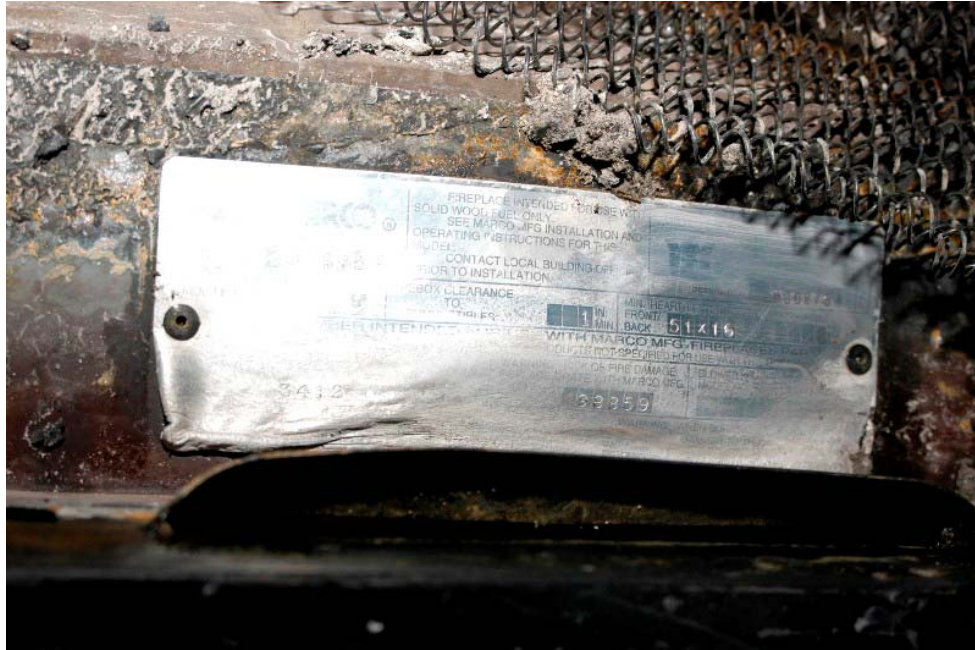
Figure 9

Identification plate from prefabricated metal firebox shows the manufacturer's name and address, and the firebox's model and serial numbers.

The reports make several points that deserve mentioning. First, both Schaal and McLauchlan noted the firebox manufacturer's name and address. This is significant because, armed with this information, Erie had the means to track down and notify the installer before the
